Inspection Report

JOHN DOE- SAMPLE REPORT

Property Address:
9483 Glenborough Drive
Elko New Market MN 55020

Closer Look Home Inspectors, L.L.C.

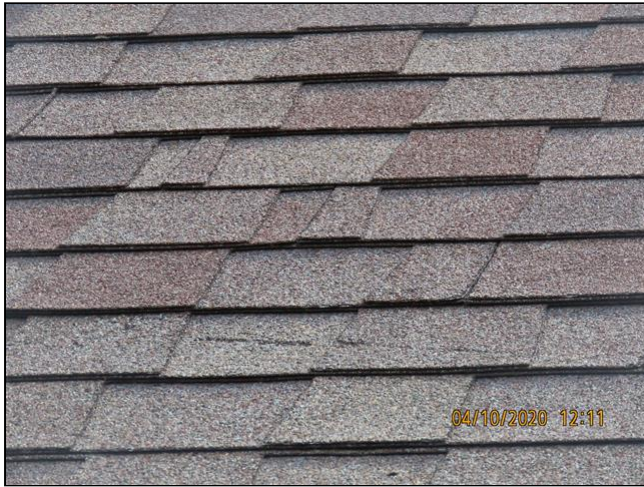
1.0 Item 1(Picture)

(2) At the time of the inspection, asphalt composition shingles covering the roof general deterioration commensurate with the age of the roof.

- Item 1(Picture) Item 2(Picture) Item 3(Picture) Apparent damage(s) in area(s).
- Inspector did not observed leaks at interior ceiling(s) at time of inspection. The attic, was not inspected.

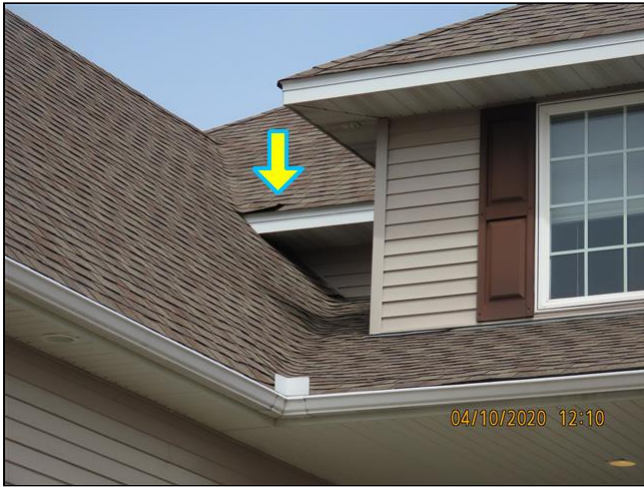
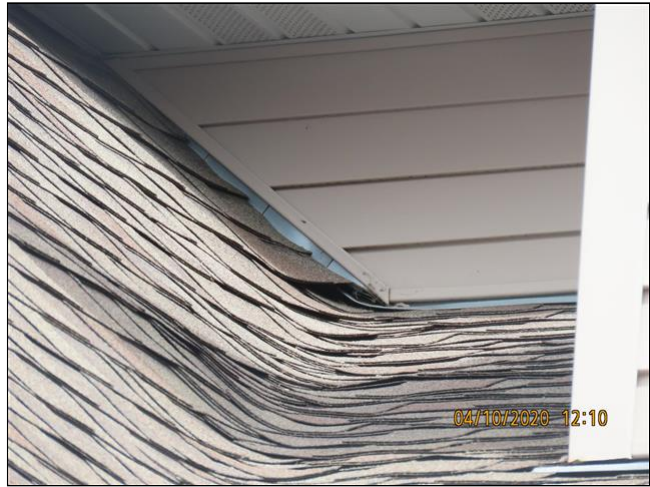
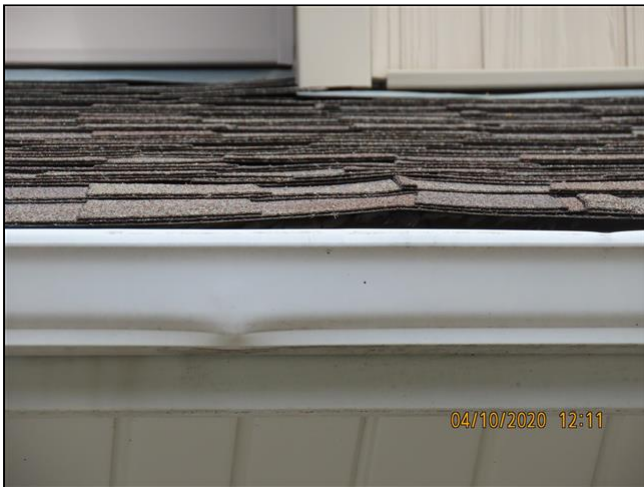
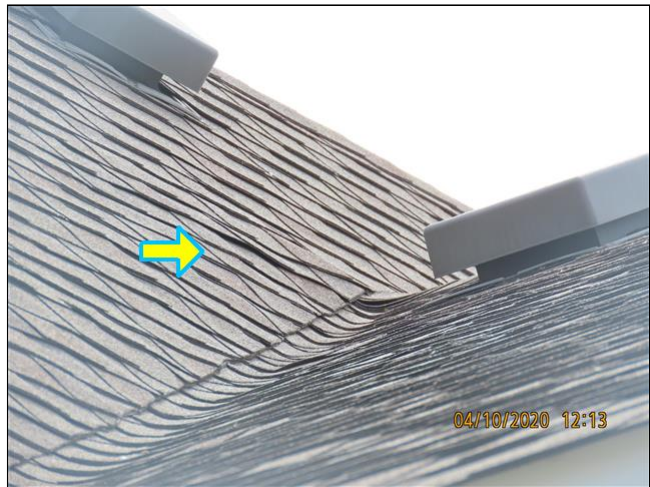
(3) At time of inspection, I observed shingle(s) at roof that were lifted in areas. This is a likely entrance point of water which can lead to further costly problems. I recommend further evaluation and correction as needed by a qualified roofing contractor.

1.0 Item 4(Picture) lifted shingle, front of home

1.0 Item 5(Picture) lifted shingle, front of home

1.0 Item 6(Picture) lifted shingle, front of home

1.0 Item 7(Picture) lifted shingle, rear of home

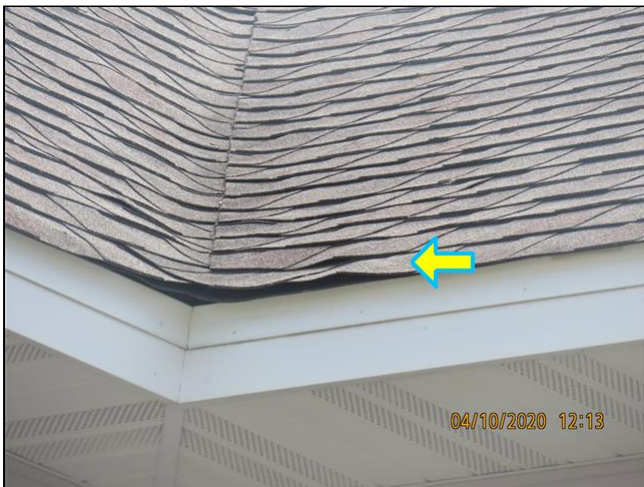
1.0 Item 8(Picture) lifted flashing rear of home

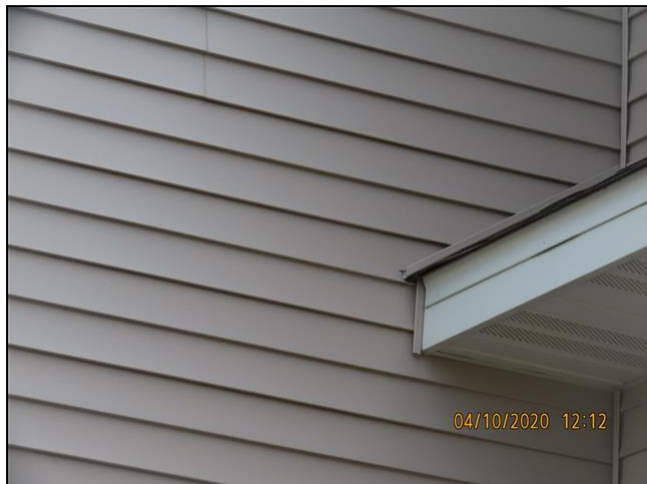
A wall section at the of the home had no kick-out flashing installed where a wall extended past a roof edge. This condition may allow moisture intrusion of the exterior wall covering. Moisture intrusion of the wall structure can damage

home materials and encourage the growth of mold. Long term moisture intrusion can cause structural damage from wood decay. The Inspector recommends correction by a qualified contractor.

1.2 Item 1(Picture) missing flashing, rear of home

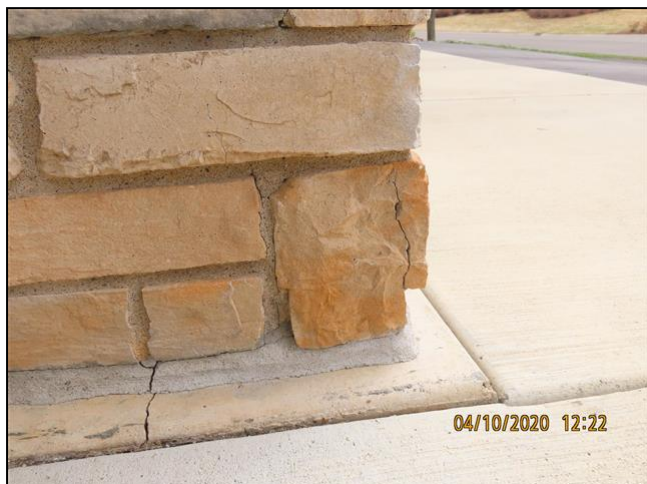
- Inspector observed what appeared to be shrinkage cracking and general wear and tear of the exterior stone, front of home. Long term proper maintenance may increase life span. If cracking continues is a qualified contractor should provide options and cost for corrections as needed
-
- Deterioration observed in areas.

2.1 Item 1(Picture) front of home, near garage door

- Cracking should be properly patched/sealed to help reduce chance of future cracking by a qualified person/contractor as needed.

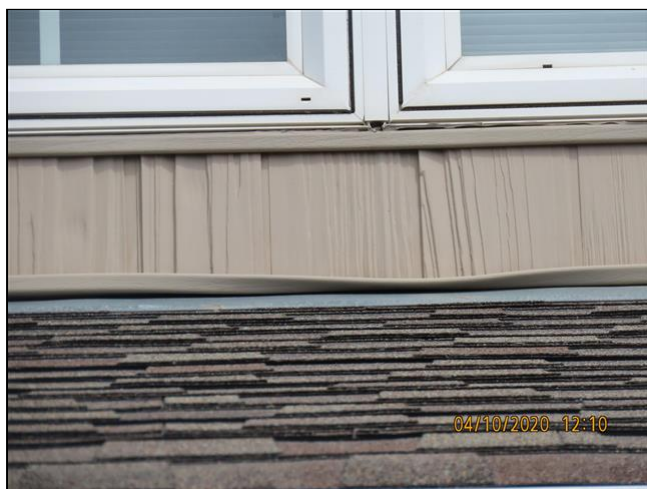
(2) Inspector observed what appeared to be a damaged or incorrectly installed trim piece at front of house. This condition may result in moisture entry towards the home. Recommended repair by a qualified person/contractor as needed.

2.3 Item 1(Picture) damaged flashing, front of home

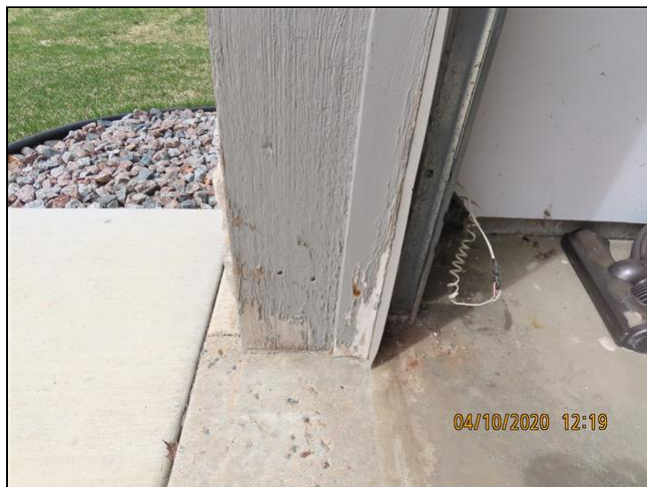
(3) I observed exposed wood at the exterior of home in areas that was peeling paint or had bare wood exposed. Recommend repainting or repair/replace as needed. All work should be performed by a qualified contractor or person. This is a general maintenance item.

2.3 Item 2(Picture) garage door trim

- Neglect may result in wood rot.

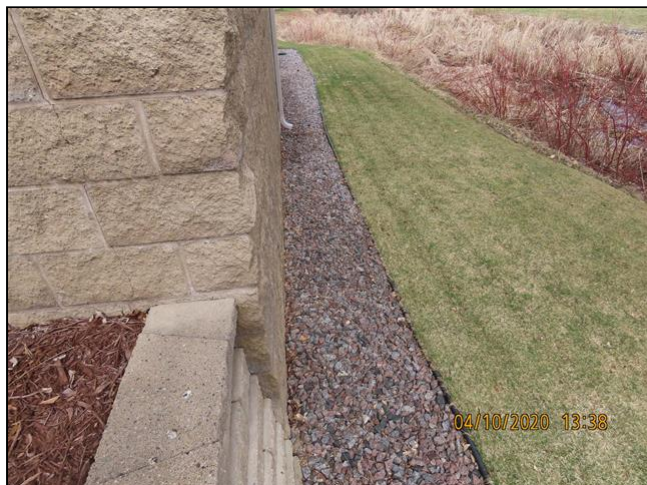
(1) The ground should slope away from the home a minimum of $\frac{1}{4}$ -inch per foot for a distance of at least six feet from the foundation. The Inspector recommends that area(s) of the home have re-grading to improve drainage near the foundation as needed. Monitor for pooling water in the yard during heavy rainfall.

2.7 Item 1(Picture) ground should slope away from the home a minimum of ¼-inch away from house

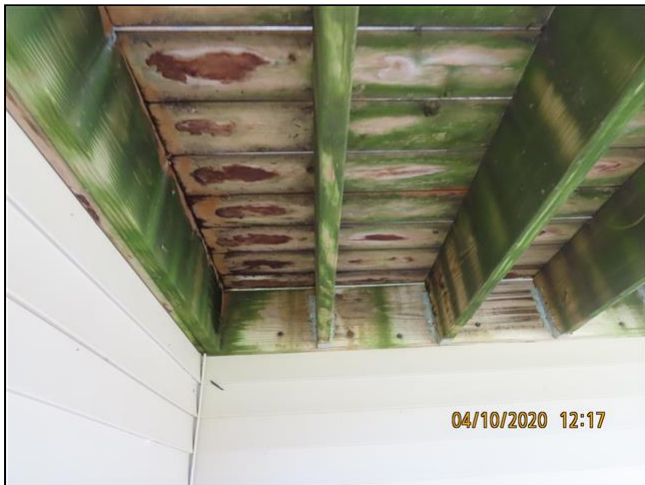
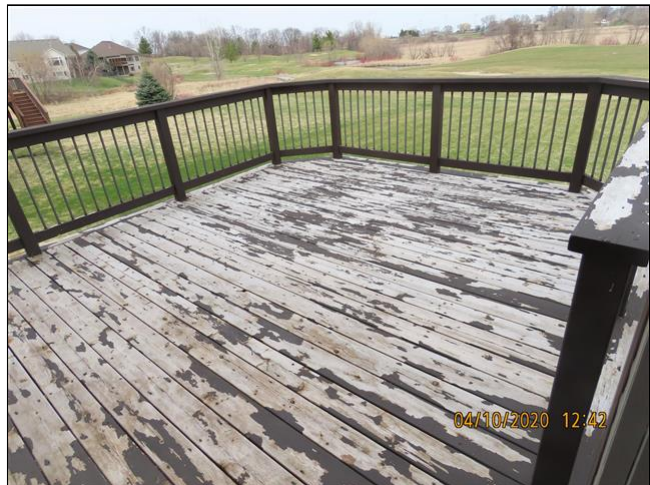
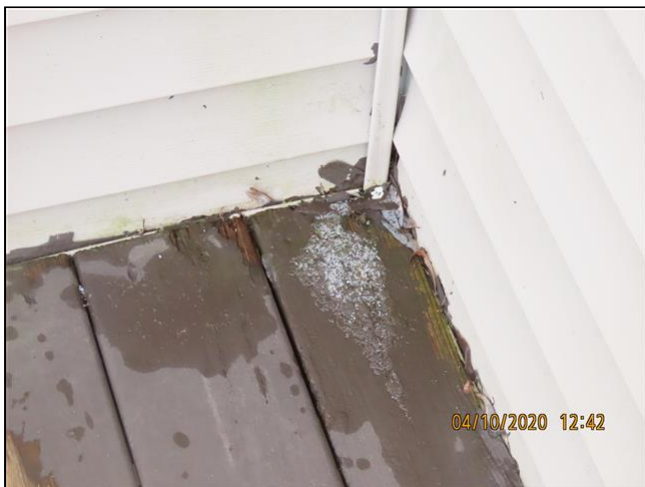
- Algae is an indication of high moisture levels. Reducing moisture may increase life span of wooden components.
- Item 2(Picture) Finish coating designed to protect the deck was not present. Failure to apply a finish coating will allow Ultra Violet (UV) radiation from sunlight, heat, moisture and freezing moisture to reduce the life span of bare wood exposed to weather.
- Item 3(Picture) - Wood rot observed in areas is indication that repair or replacement is needed in areas. Recommend further evaluation and correction as needed by a qualified contractor.
 -
 - Maintenance performed on an appropriate schedule can significantly extend the life span of wood deck components

2.8 Item 1(Picture) rear of home

2.8 Item 2(Picture) rear of home

2.8 Item 3(Picture) rear of home

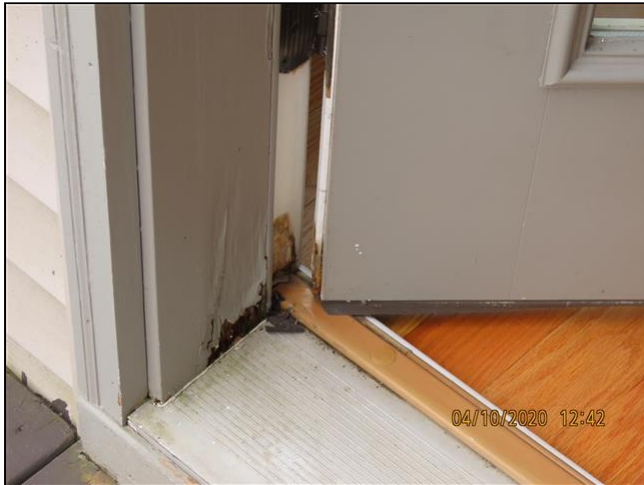
- Item 1(Picture) wood rot at exterior door(s), 4 locations.
- Item 2(Picture) advanced wood rot, hardware difficult to operate, door was difficult to operate, light moisture entry observed at interior of home near trim.

2.9 Item 1(Picture) rear of home, at deck

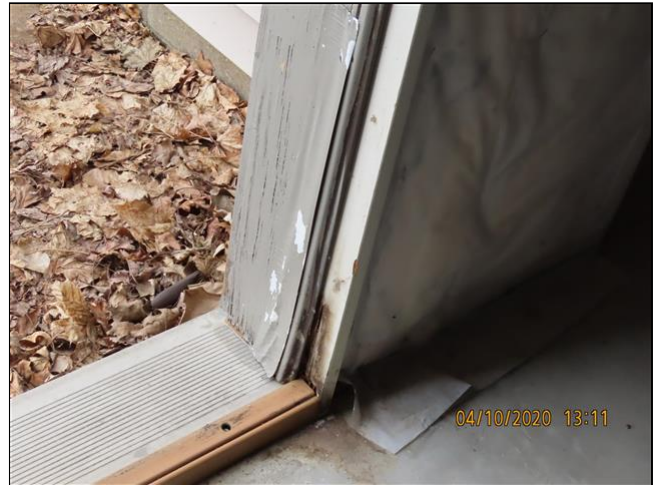
2.9 Item 2(Picture) rear of home, basement exterior door

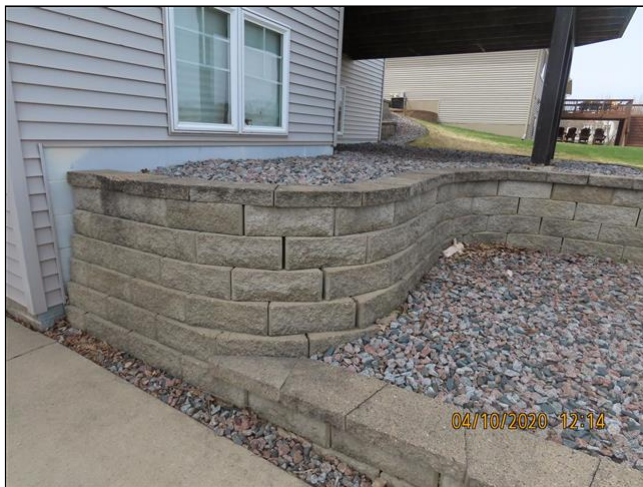
2.16 Item 1(Picture)

Inspector observed what appeared to be displacement and or settlement at exterior boundary wall. If shifting or cracking continues a qualified person or contractor should repair to reduce chance of blacks falling or slipping. Reducing moisture in the nearby area may decrease chance of settlement.

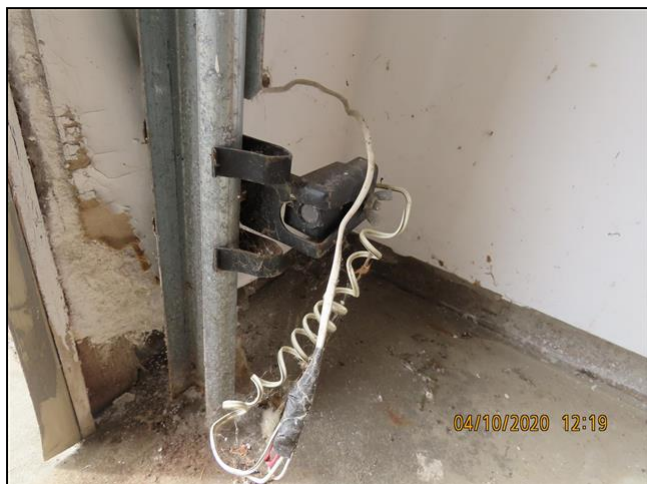
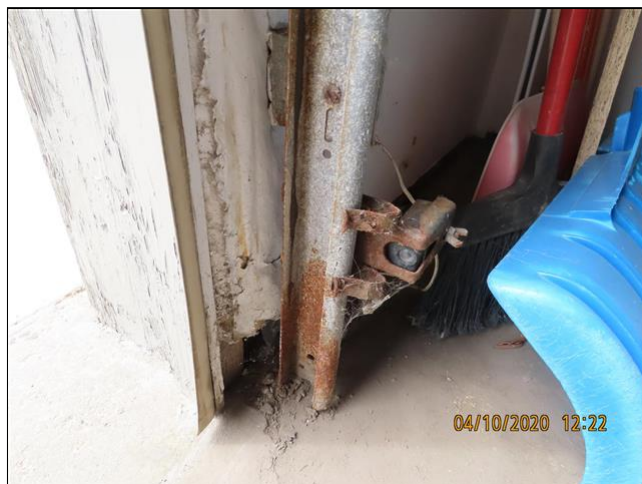
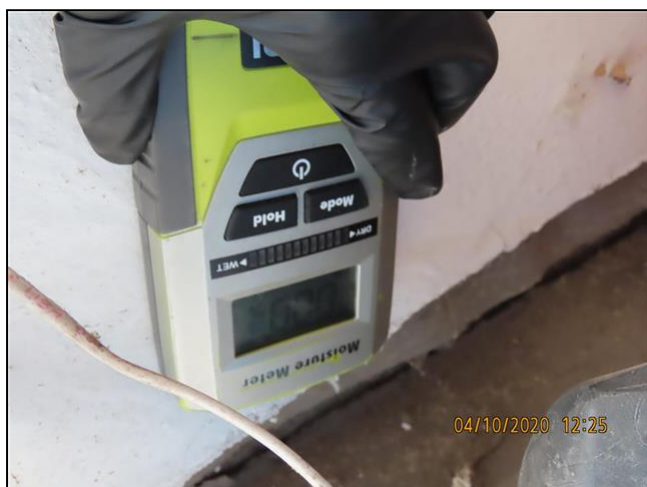
has not been recent. The lack of elevated moisture levels may be an indication that the source of leakage has been corrected. You should ask the seller about this condition.

3.2 Item 1(Picture) localized moisture near overhead garage doors

3.2 Item 2(Picture) localized moisture near overhead garage doors

3.2 Item 3(Picture) area(s) dry at time of inspection.

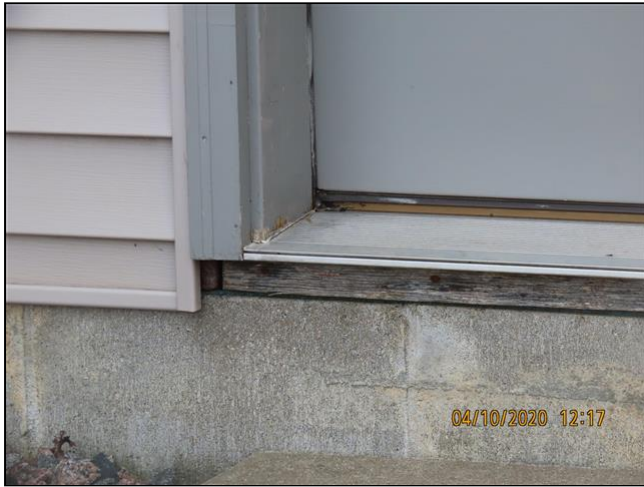
- Item 1(Picture) Exposed wood may deteriorate over time. Recommend proper general maintenance to increase life span.
- Item 2(Picture) Wood rot/peeling paint, conventional garage door(s) may be nearing end of useful life span. Repair/replace as needed to reduce chance of damages to nearby components.

3.3 Item 1(Picture) rear of home

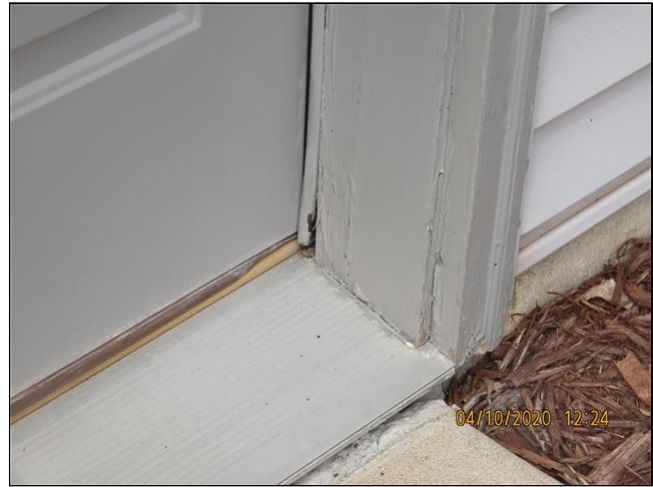
3.3 Item 2(Picture) front of home

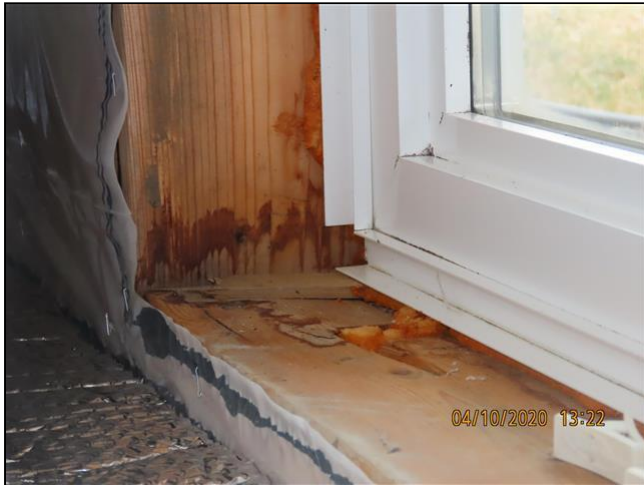
4.7 Item 1(Picture)

(2) Inspector observed stains at or near interior windows in three or more locations. The areas were dry at time of inspection indicating the source is intermittent or has been repaired. You may wish to ask seller about this condition.

- See item 8.1 for more information. (Staining near corners of windows may indicate high moisture levels.)
- Determining exact cause and future moisture entry goes beyond the scope of a home inspection.

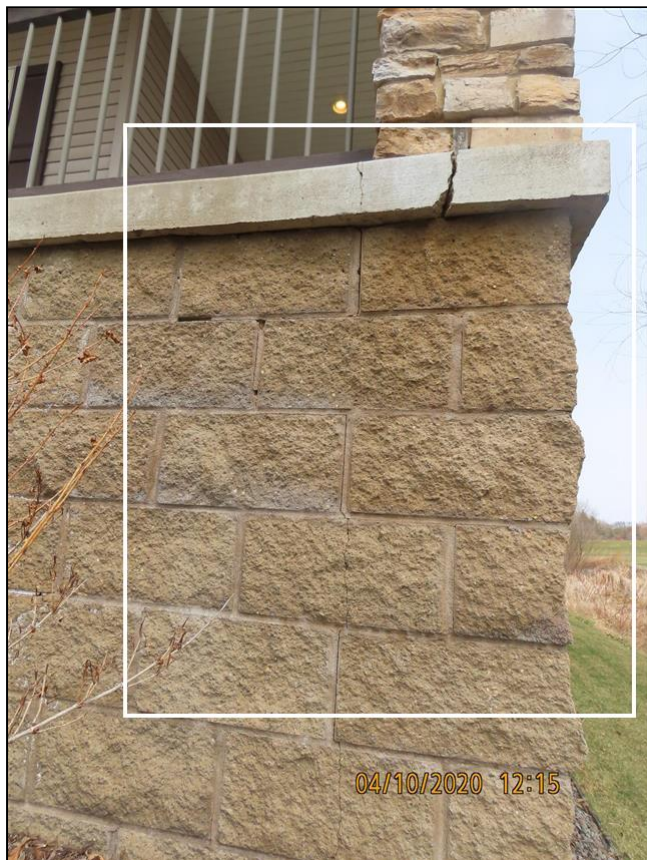
- Determining exact cause and future settlement goes beyond the scope of a home inspection. Inspector recommends cracks be properly patched or sealed to reduce chance of freeze cracking. You may wish to obtain any cost estimates before the end of your inspection deadline.

5.0 Item 1(Picture) front right corner of home, facing front

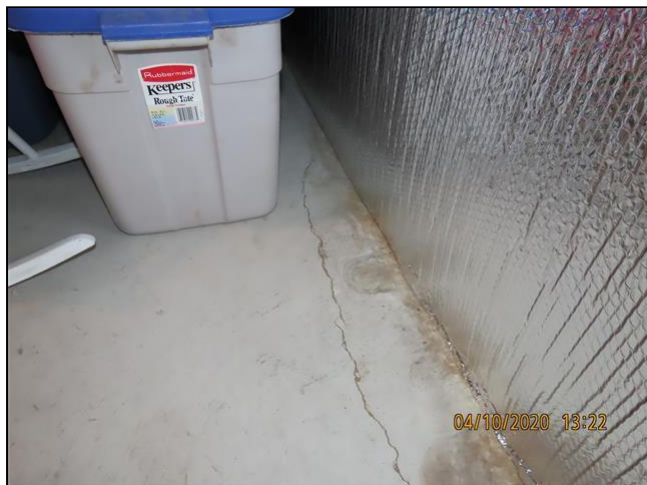
5.2 Item 1(Picture)

If cracking continues, a contractor should confirm this finding and provide options and cost for correction as needed.

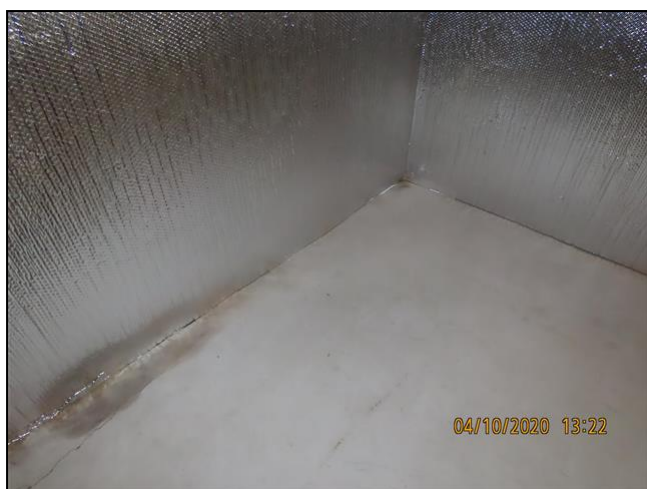
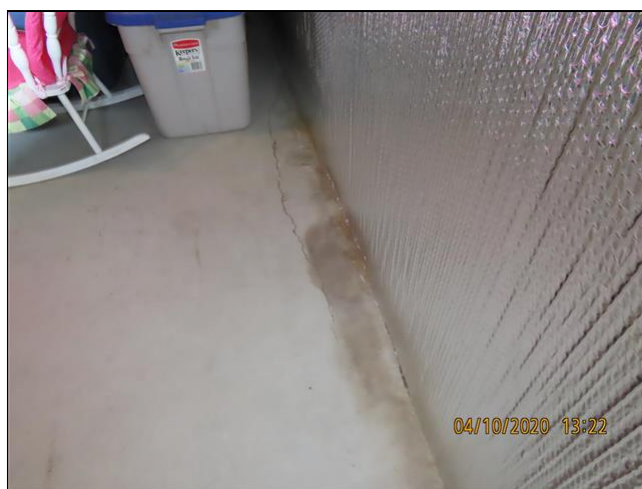
- The area was dry at time of inspection.
- Inspector recommends asking seller about moisture entry in this area. A qualified contractor should confirm this finding as needed. Determining future moisture entry goes beyond the scope of a home inspection. Reducing moisture may decrease chance of microbial growth.

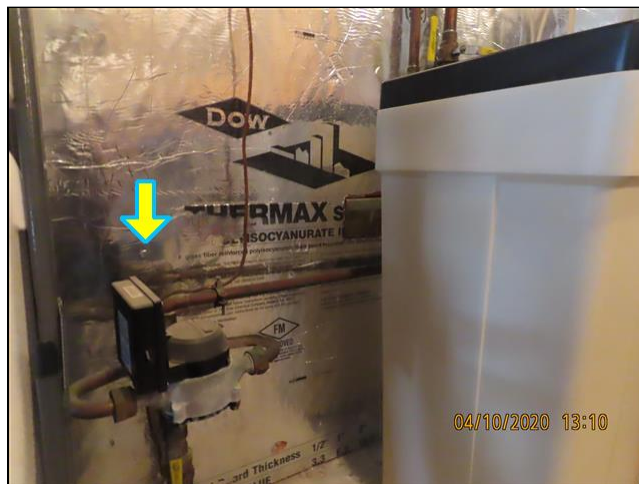
main water supply

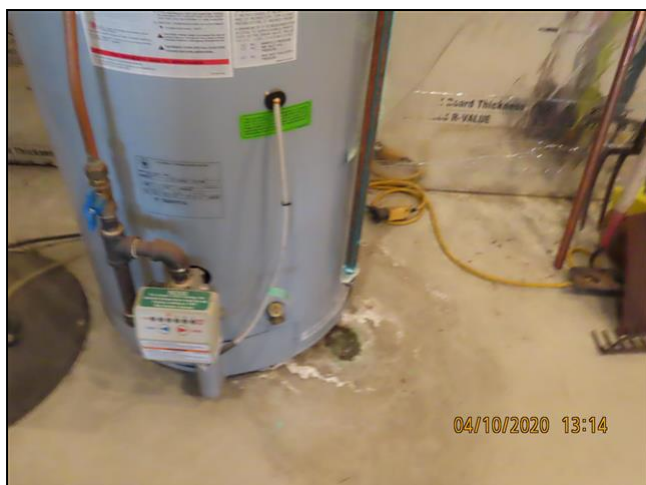
6.3 Item 2(Picture)

- Current water temp 118F - satisfactory
- Water heater Manufacture date: appears to be 2004

- Inspector recommends replacement of the water heater. You may wish to obtain a cost estimate before the end of your inspection deadline.

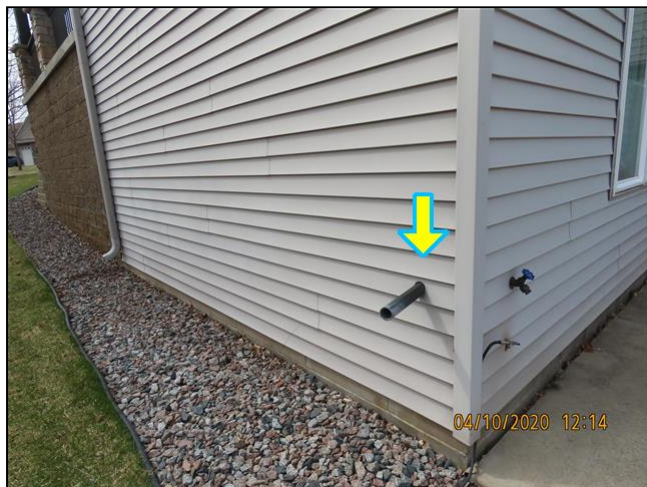
6.4 Item 1(Picture)

- Item 1(Picture) Extension of the sump pump drain line needed to reduce chance of moisture near the foundation.
- The sump pump appears to be reliant on an extension cord. You may wish to have an electrician provide options and costs for corrections as needed.

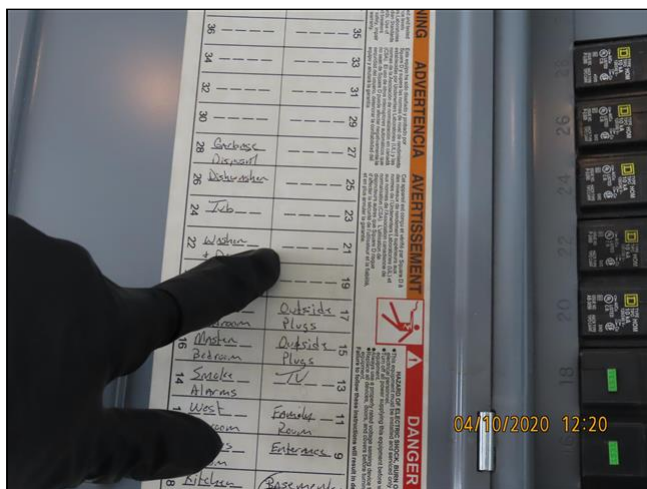
7.0 Item 2(Picture)

(2) The circuits for the main electrical panel legend in the home were not fully labeled during the inspection. Circuits which are not labeled may prevent the ability for proper operation including shut-off. As such the circuits should be identified and labeled within the panel legend.

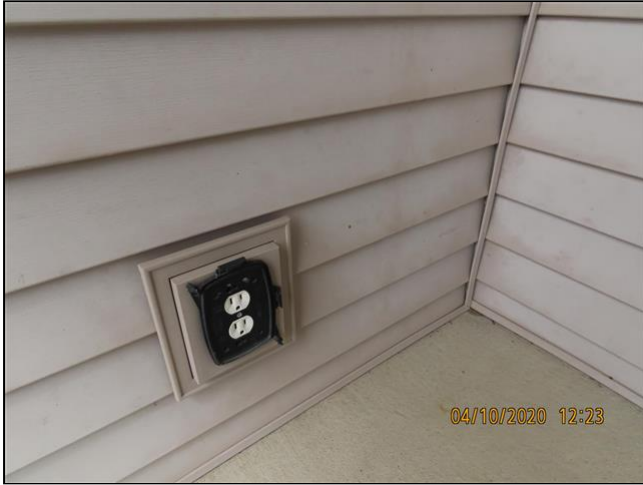
- Item 1(Picture) replace missing weather protected cover
- Item 2(Picture) - appears to have open/neutral
- Item 3(Picture) - upstairs bedroom electrical receptacle was loose, re-secure as needed.

7.3 Item 1(Picture) front of home, near main entry

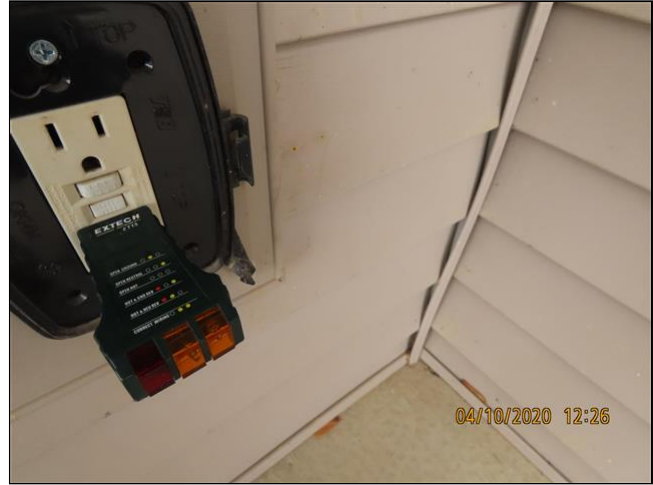
7.3 Item 2(Picture) front entry porch

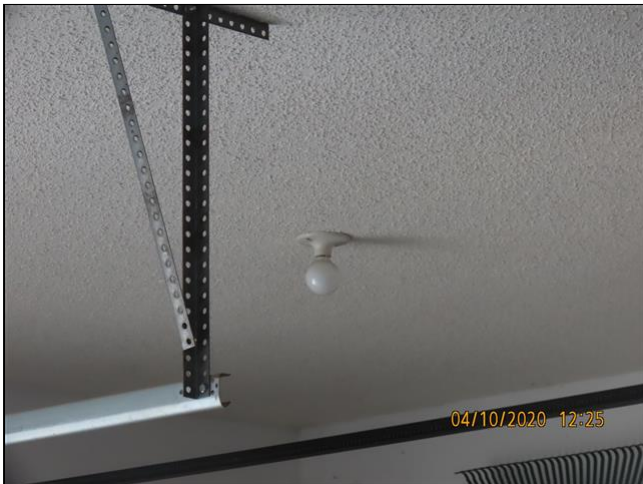
- An interior fan/light was loose or wobbled when in operation. This is a general maintenance item.
- Two light bulbs in the garage were not responding. If after the bulbs are replaced this light still fails to respond to the switch, a qualified electrical contractor should further evaluate and correct as needed to ensure proper conditions exist.

7.4 Item 1(Picture) garage

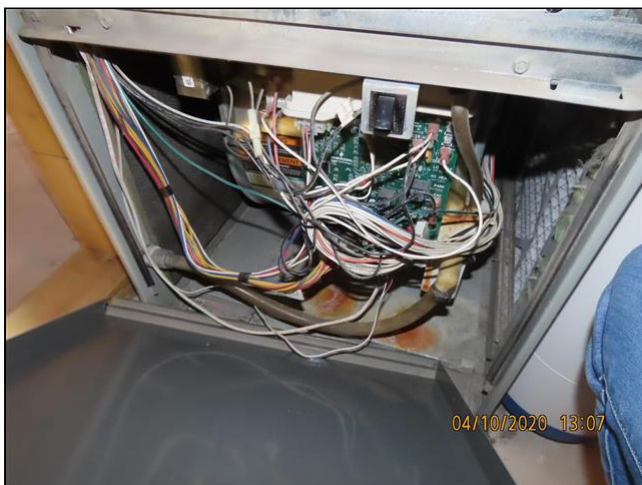
8.0 Item 2(Picture)

(2) Inspector observed what appeared to be rust or corrosion at interior cabinet of furnace indicating the source may be intermittent or has been repaired.

- You may wish to ask the seller about this condition or any past maintenance records. Determining exact cause and future moisture goes beyond the scope of a home inspection. A qualified HVAC technician can confirm this finding as needed.
- Inspector recommends proper maintenance to increase lifespan. This is considered a general maintenance

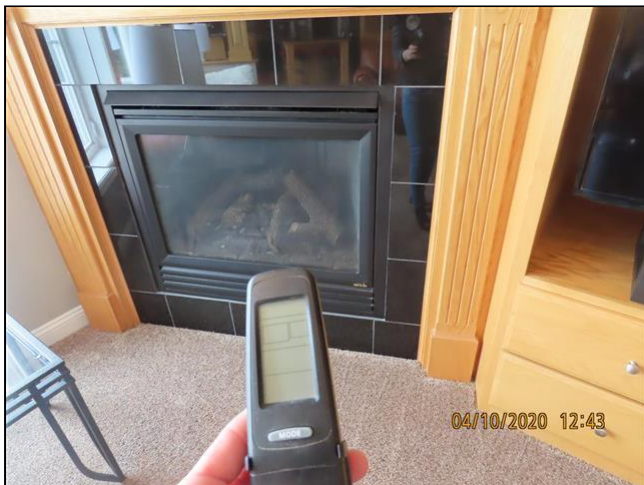
8.4 Item 1(Picture)

(2) The batteries for the fireplace were not installed or were not working at time of inspection. The fireplace was not fully inspected.

- The pilot light was ON at time of inspection.
- Recommend asking seller to disclose the condition of the fireplace
- Inspector recommends annual maintenance on the gas fireplace, as with any other gas appliance.

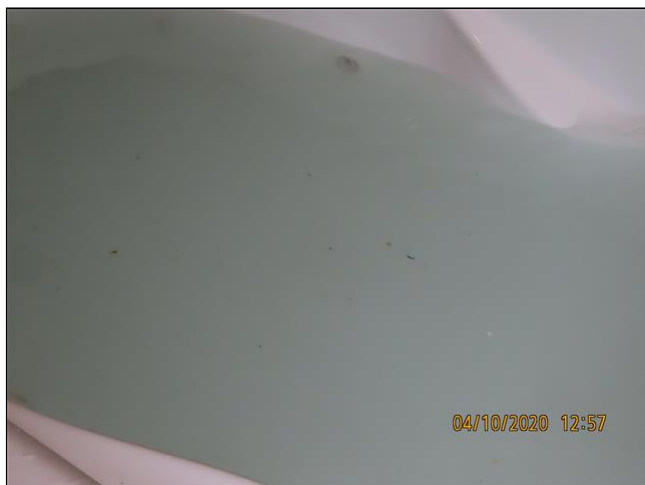
10.0 Item 1(Picture)

The master bathroom jet tub appeared to have debris in the jet system when inspector operated the water jets. Determining exact cause goes beyond the scope of a home inspection.

- The most common is dirty plumbing. Scum and other organic build up, caused by body lotions, oils, cosmetics, and hair products brought into the spa by bathers may occur in your plumbing lines that eventually flakes away and comes out when the jets are turned on.
- If this condition continues after several uses and proper cleaning, a qualified technician should further evaluate and correct as needed.

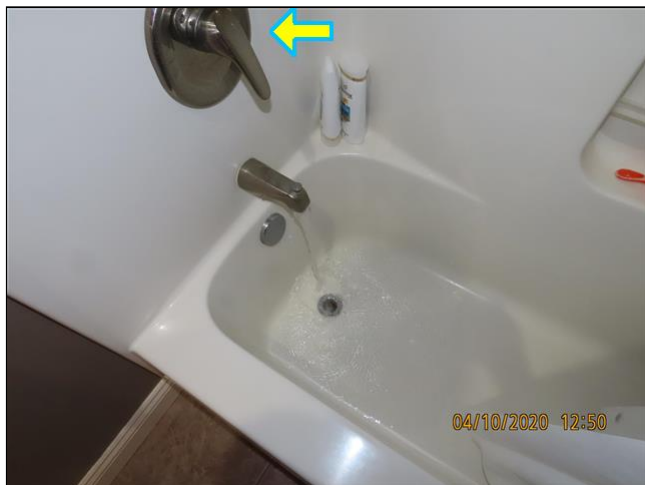
- Item 1(Picture) Missing hardware, water stopper. Replace as needed. General maintenance item.
- Item 1(Picture) - hardware (handle) had what appeared to be an intermittent leak when the water source was turned on. Inspector was not able to determine how often this will occur. Recommend monitoring or replacement as needed. General maintenance item.
- The shower head in the upstairs master bathroom leaked when in operation. Recommend tightening the hardware or replacement as needed by a qualified person. General maintenance item.

10.2 Item 1(Picture) upstairs hallway bathroom shower

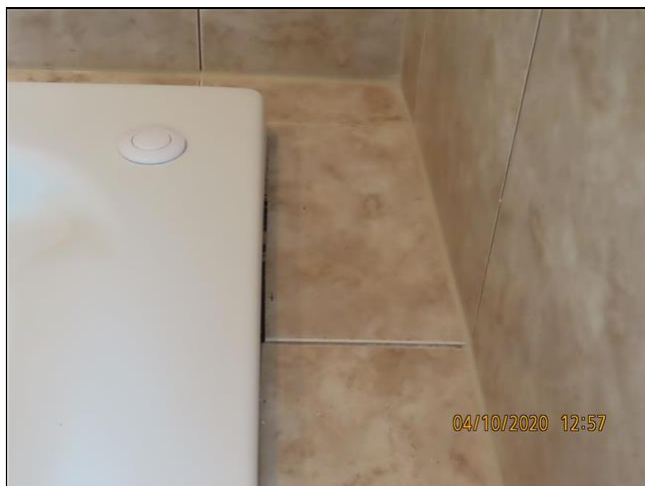
10.5 Item 1(Picture)

Small amounts of missing mortar/sealant observed. This may allow moisture intrusion of the wall assembly. The Inspector recommends replacement by a qualified person/contractor as needed. General maintenance item.

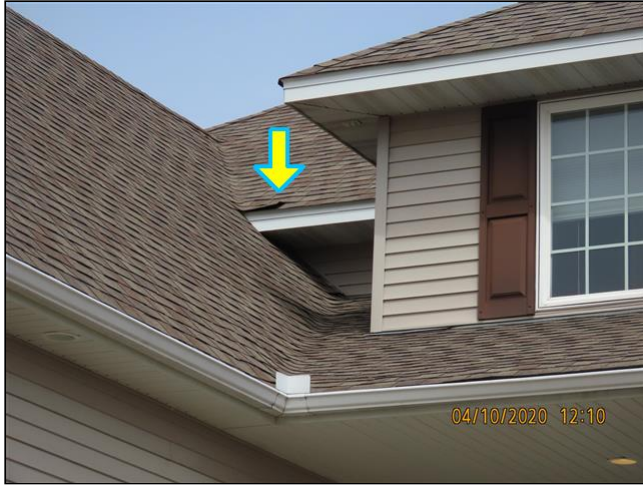
(3) At time of inspection, I observed shingle(s) at roof that were lifted in areas. This is a likely entrance point of water which can lead to further costly problems. I recommend further evaluation and correction as needed by a qualified roofing contractor.

1.0 Item 4(Picture) lifted shingle, front of home

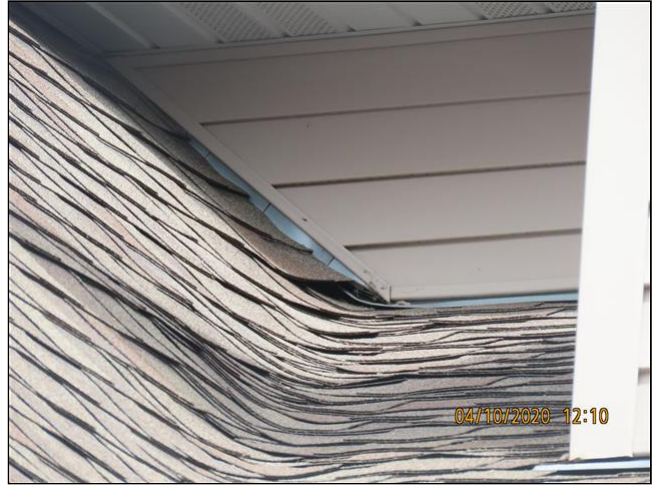
1.0 Item 5(Picture) lifted shingle, front of home

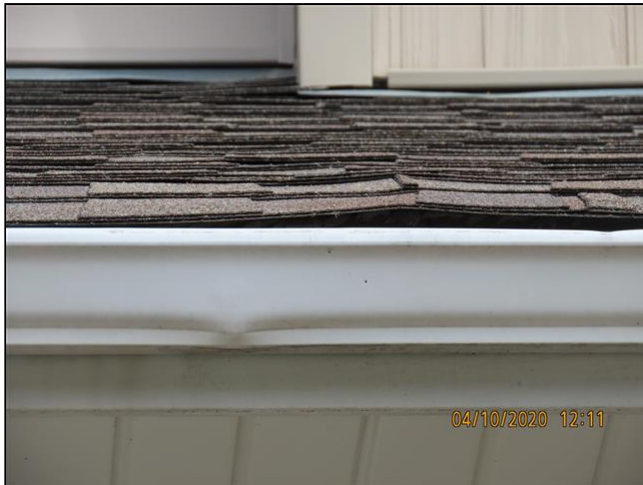
1.0 Item 6(Picture) lifted shingle, front of home

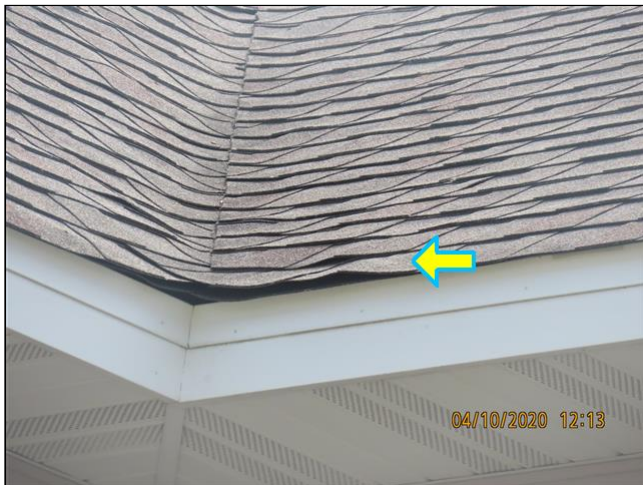
1.0 Item 8(Picture) lifted flashing rear of home

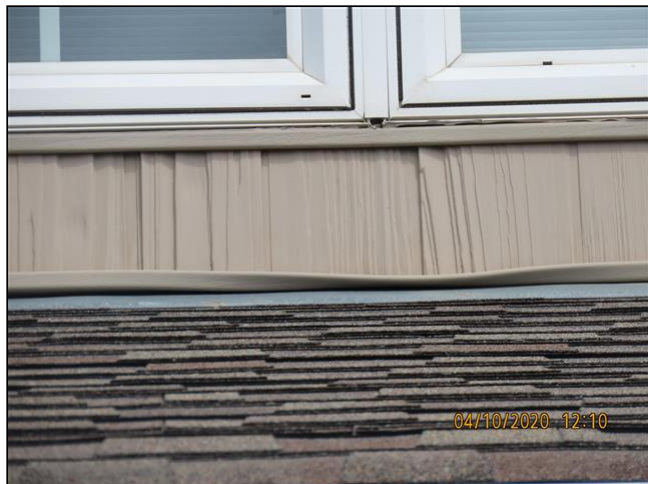
(2) Inspector observed what appeared to be a damaged or incorrectly installed trim piece at front of house. This condition may result in moisture entry towards the home. Recommended repair by a qualified person/contractor as needed.

2.3 Item 1(Picture) damaged flashing, front of home

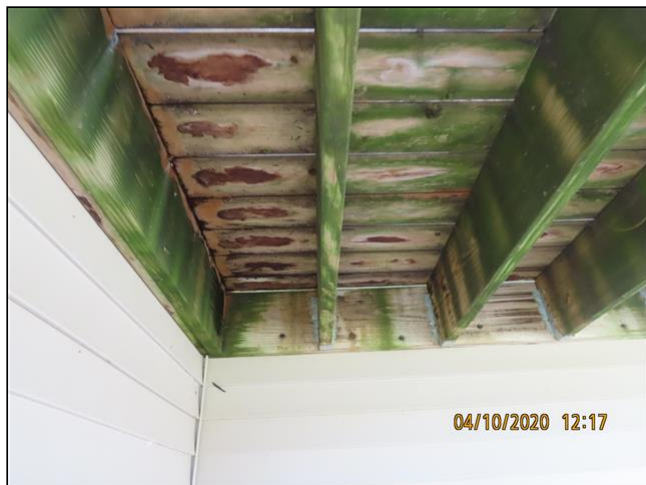
The deck showed moderate to advanced wear-and-tear commensurate with age. You may wish to obtain a cost estimate for any and all repairs before the end of your inspection.

2.8 Item 1(Picture) rear of home

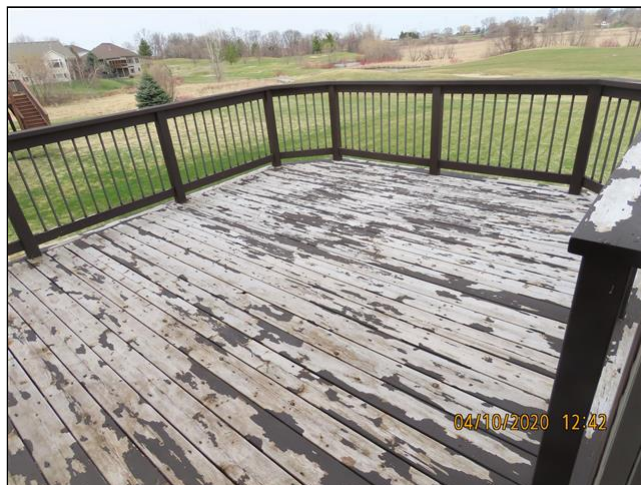
- Algae is an indication of high moisture levels. Reducing moisture may increase life span of wooden components.
- Item 2(Picture) Finish coating designed to protect the deck was not present. Failure to apply a finish coating will allow Ultra Violet (UV) radiation from sunlight, heat, moisture and freezing moisture to reduce the life span of bare wood exposed to weather.
- Item 3(Picture) - Wood rot observed in areas is indication that repair or replacement is needed in areas. Recommend further evaluation and correction as needed by a qualified contractor.
 - Maintenance performed on an appropriate schedule can significantly extend the life span of wood deck components

2.8 Item 2(Picture) rear of home

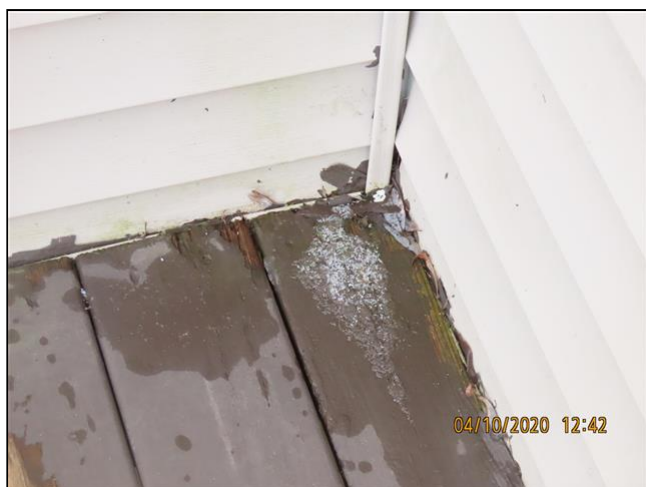
2.8 Item 3(Picture) rear of home

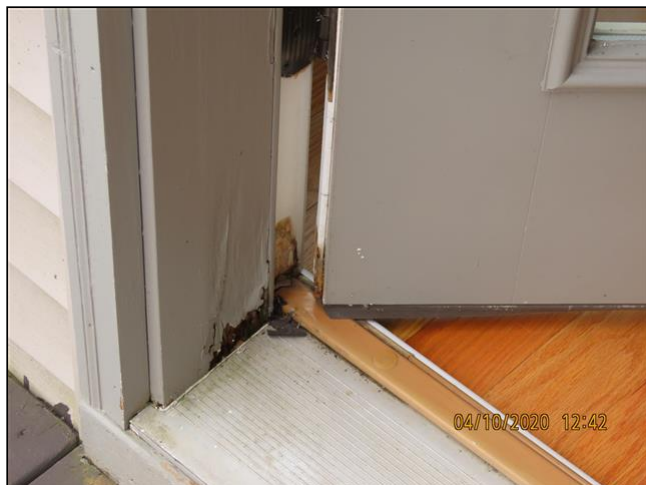
- Item 1(Picture) wood rot at exterior door(s), 4 locations.
- Item 2(Picture) advanced wood rot, hardware difficult to operate, door was difficult to operate, light moisture entry observed at interior of home near trim.

2.9 Item 1(Picture) rear of home, at deck

(2) You may wish to obtain a cost estimate for the following before the end of your inspection deadline.

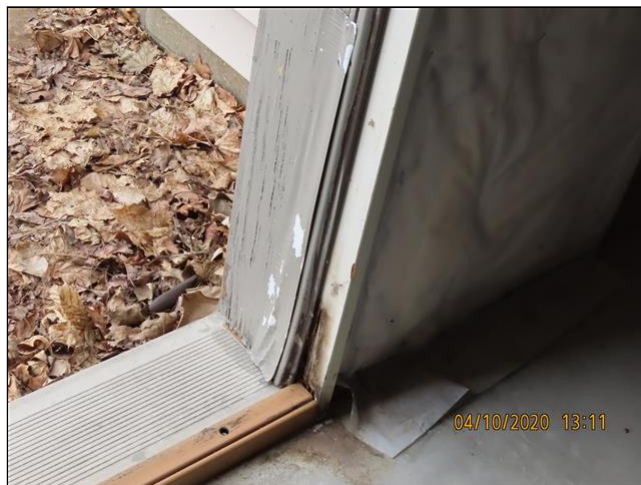
2.9 Item 2(Picture) rear of home, basement exterior door

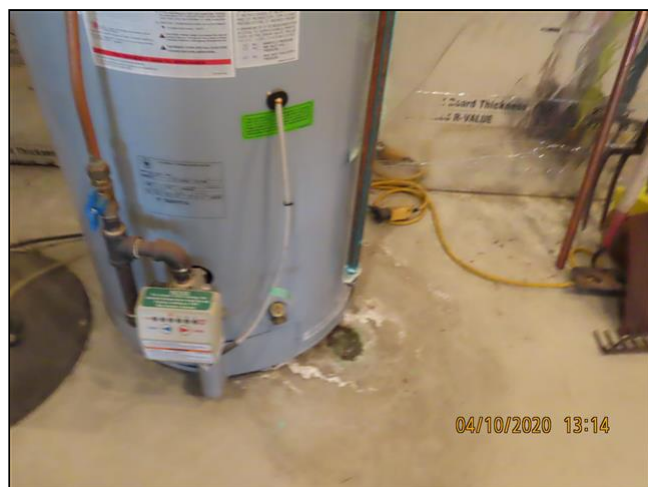
6.3 Item 2(Picture)

(2) The water heater was actively leaking at the TPR valve at time of inspection. Inspector observed moderate to advanced corrosion which is indication the water heater is at the end of its useful life span.

- Inspector recommends replacement of the water heater. You may wish to obtain a cost estimate before the end of your inspection deadline.

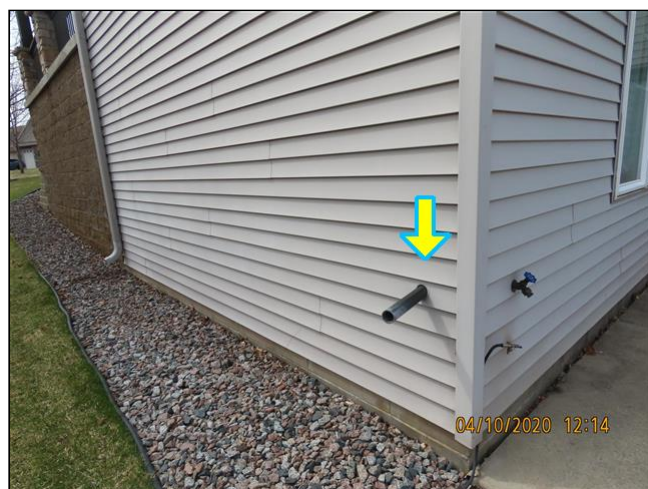
6.4 Item 1(Picture)

- Item 1(Picture) Extension of the sump pump drain line needed to reduce chance of moisture near the foundation.
- The sump pump appears to be reliant on an extension cord. You may wish to have an electrician provide options and costs for corrections as needed.

(2) Recommend the following corrections as needed by a qualified person or contractor.

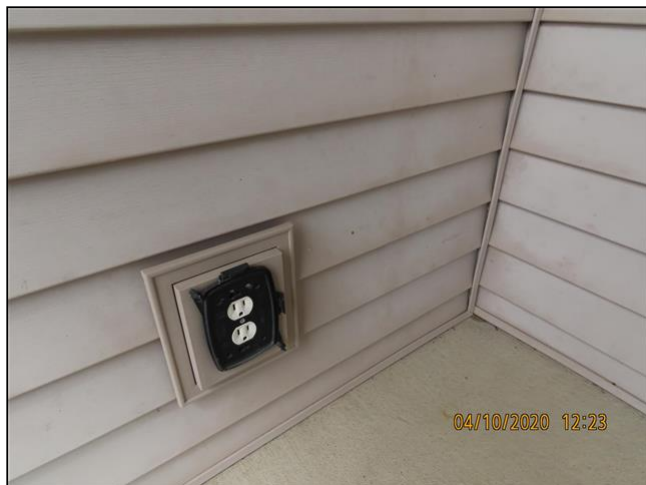
- Item 1(Picture) replace missing weather protected cover
- Item 2(Picture) - appears to have open/neutral
- Item 3(Picture) - upstairs bedroom electrical receptacle was loose, re-secure as needed.

7.3 Item 1(Picture) front of home, near main entry

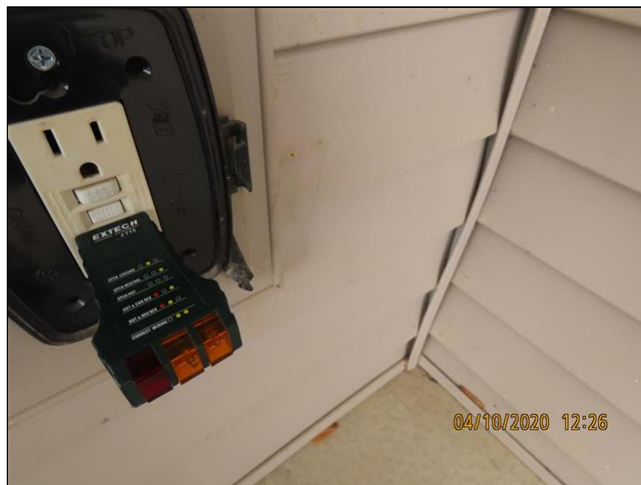
7.3 Item 2(Picture) front entry porch

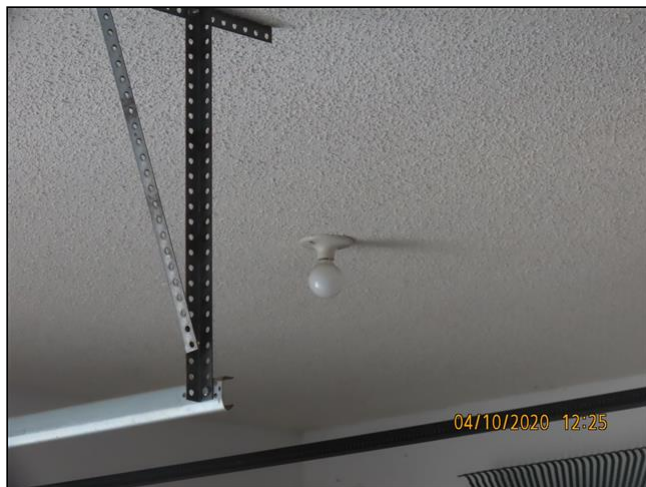
- An interior fan/light was loose or wobbled when in operation. This is a general maintenance item.
- Two light bulbs in the garage were not responding. If after the bulbs are replaced this light still fails to respond to the switch, a qualified electrical contractor should further evaluate and correct as needed to ensure proper conditions exist.

7.4 Item 1(Picture) garage

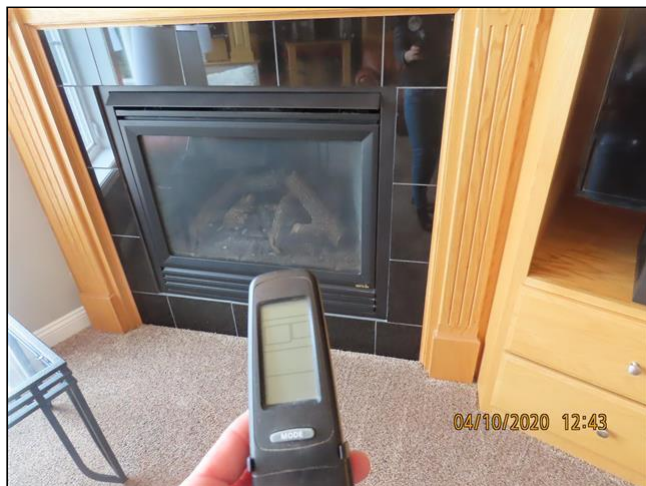
8.4 Item 1(Picture)

(2) The batteries for the fireplace were not installed or were not working at time of inspection. The fireplace was not fully inspected.

- The pilot light was ON at time of inspection.
- Recommend asking seller to disclose the condition of the fireplace
- Inspector recommends annual maintenance on the gas fireplace, as with any other gas appliance.
